# Bulletin

SRN - 1347  
 APC - 432,466  
 Sept 2001

From: MTS2000 Subscriber Product Group  
 Subject: **In-Band High Level Intermodulation Enhancement for MTS2000 800MHz Radios**

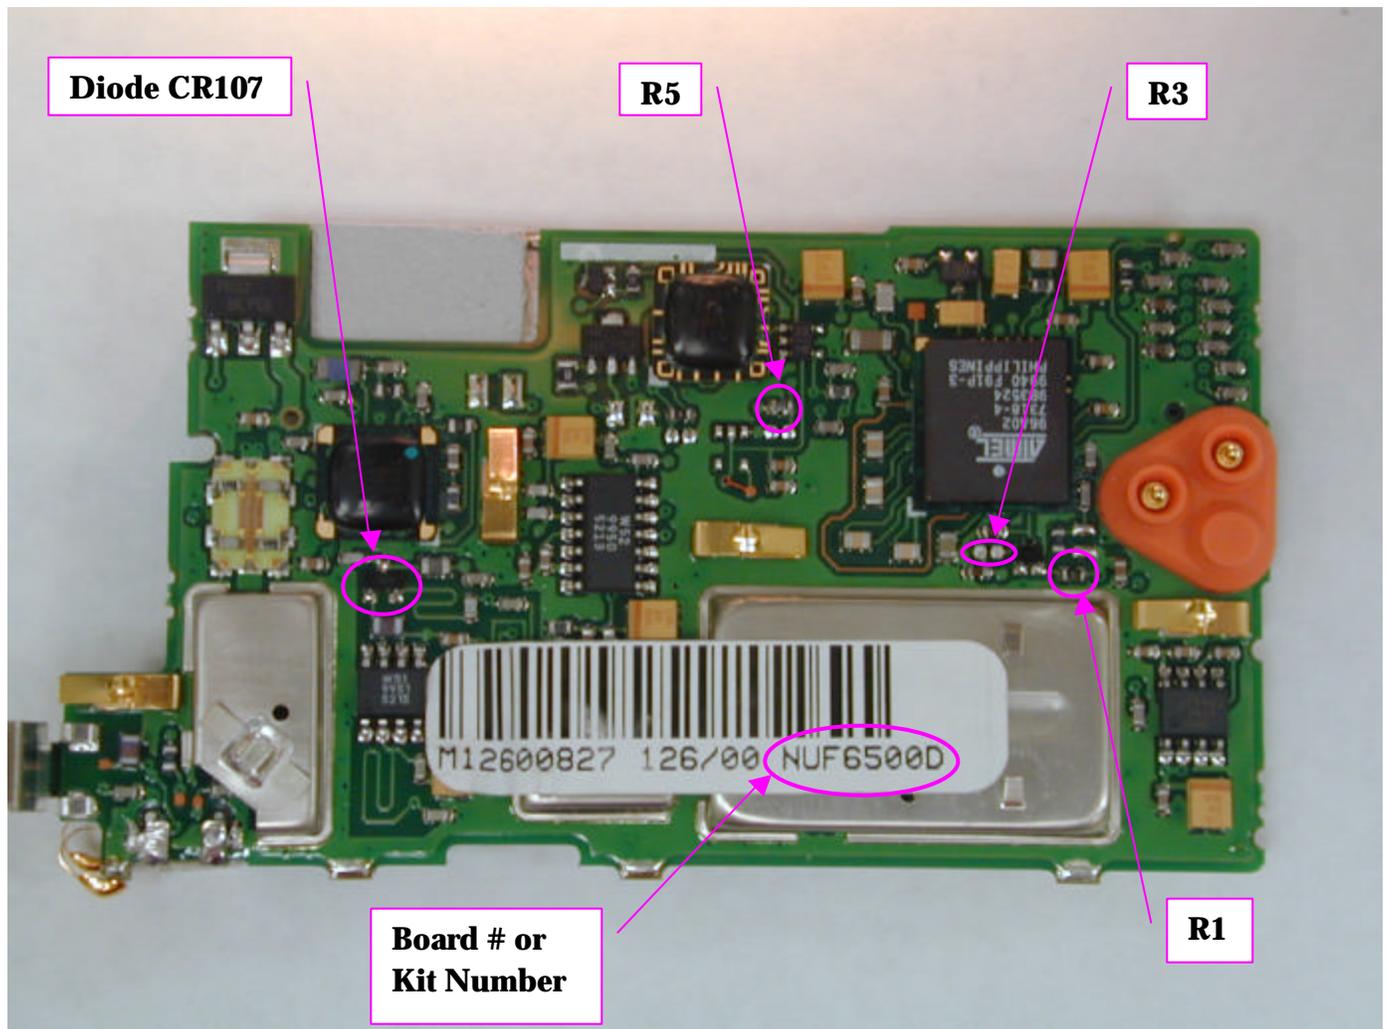
## Figure 1 - Location of Components

Due to spectrum allocations that have placed commercial mobile radio service (“CMRS”) providers in the same band as Public Safety systems, some 800MHz Public Safety radios are experiencing interference in close proximity to CMRS sites. This interference can result in missed calls or unintelligible audio, even though the Public Safety receivers are operating in accordance with their published specifications.

Intermodulation products of strong in-band signals (experienced close to CMRS sites) and the desired Public Safety signal may cause degraded receiver performance. APCO has published a “Best Practices” guide (available at <http://apointl.org/afc/800bpg.htm>, then click on “Best Practices Guide”) that suggests several approaches to this problem for new and existing systems (see Best Practices Guide, pages 11-14). If the problem cannot be resolved by the suggested methods, it is in some cases possible to improve the situation by modifying the Public Safety subscriber radios. This bulletin details modifications that can be made to the MTS2000 portable radio to improve its performance in high-level IM environments.

1. Disassemble the radio in accordance with section 6 of the manual (pg. 29 – 33); kit number is located on the bar code label on the PCB as shown in Figure 1.
2. Remove Diode CR107 shown in Figure 1.
3. Place Capacitor part number 2113740A06 in place of the diode as shown in Figure 2. One end of the capacitor should bridge two of the diode pads.
4. Re-assemble the radio in accordance with section 6 of the manual (pg. 36 - 38).

1. Disassemble the radio in accordance with section 6 of the manual (pg. 29 – 33).
2. Replace resistor R1 with part number 0662057A42
3. Remove resistor R3.
4. Place resistor R5, part number 0662057A73, in location shown in Figure 1.
5. Re-assemble the radio in accordance with section 6 of the manual (pg. 36 – 38).
6. If the **radio** contains **firmware older than R06.50**, upgrade the radio firmware to the latest release.
7. Perform basic Sensitivity and power test to verify radio's basic functionality
